## **Impact on the Design Life of Buildings in a Tropical Hot Wet Environment**

**K. Gurusamy**  
JTK Consult Sdn. Bhd.  
46B, Lorong Rahim Kajai 14, Taman Tun Dr. Ismail,  
Kuala Lumpur, Malaysia.  
[kribangn@jtkconsult.com.my](mailto:kribangn@jtkconsult.com.my)

### **ABSTRACT**

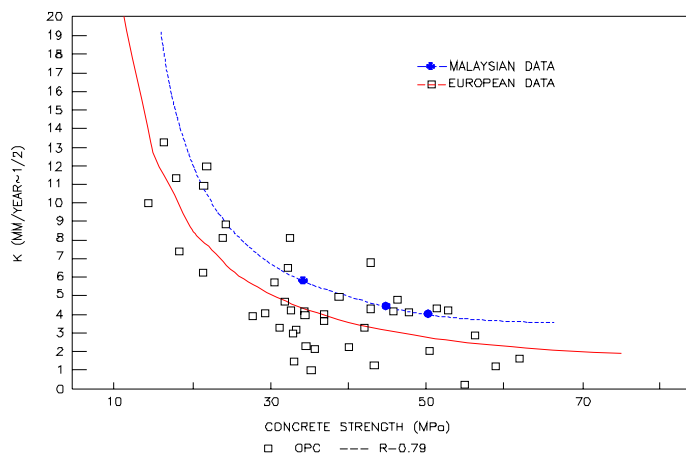
Figure 3: 'k' vs 28 days concrete strength – Interior Environment for European and Malaysian conditions.

Considerable data had been gathered as part of a European funded research programme undertaken by Taywood Engineering (M) where a comprehensive review of carbonation data had been undertaken resulting in design life prediction curves. These results for carbonation penetration are summarised in Table 4 and compared to local Malaysian data. The carbonation data discussed from Johor Bahru fits well into the European data range for 30 and 40 MPa concrete for interior exposure. Due to the higher temperatures in Malaysia, approximately 10°C higher on average compared to UK, a doubling in penetration rate would have been expected based on the Arrhenius law. This appears not to be the case most likely due to the higher relative humidities typical of Malaysia and the fact that concrete will not have sufficient time to dry out in the 7-8 hours where the RH is between 50-70% over a 24-hour period. The Malaysian results are however on the higher side of the predicted curve (see Fig. 3). It should also be noted that the rate of carbonation will depend on variability in the local materials used for the concrete production and the efficiency of concrete curing.

- Note: <sup>(1)</sup> Johor Bahru Data, Hospital Sultanah Aminah  
<sup>(2)</sup> Johor Bahru Data, Hospital Sultanah Aminah  
<sup>(3)</sup> 'k' value based on design curve for European conditions (see Fig. 3)  
<sup>(4)</sup> 'k' value corrected for Malaysian conditions (see Fig. 3)
